RoHS Compliancy Test Report

All tests reported are performed on a Horiba XGT-1000WR and meet the procedures set forth by IPC document 111/2/NP

KVAR ENERGY

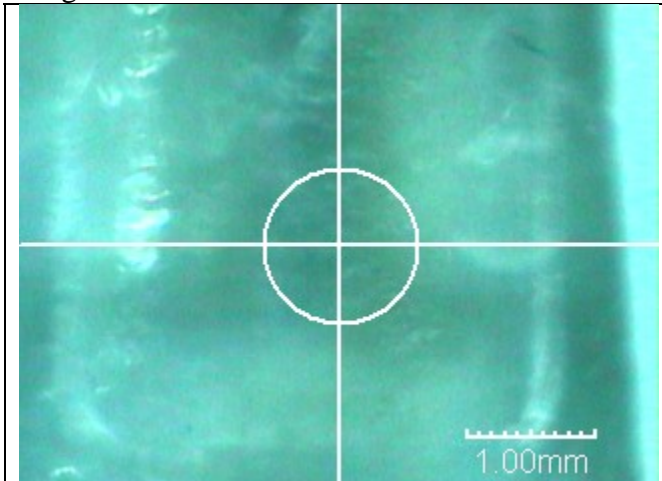
Magnified Picture

Test #: NAC100691
 Date/Time: 6/27/2007 1:22:00 PM
 Part Number: COVER PLATE
 Manufacture: MISC
 Lot#: UNKNOWN

Material	Element	MDL	ppm
Metal	Br	1000	N.D.
	Cr	1000	N.D.
	Hg	1000	N.D.
	Cd	100	N.D.
	Pb	1000	N.D.

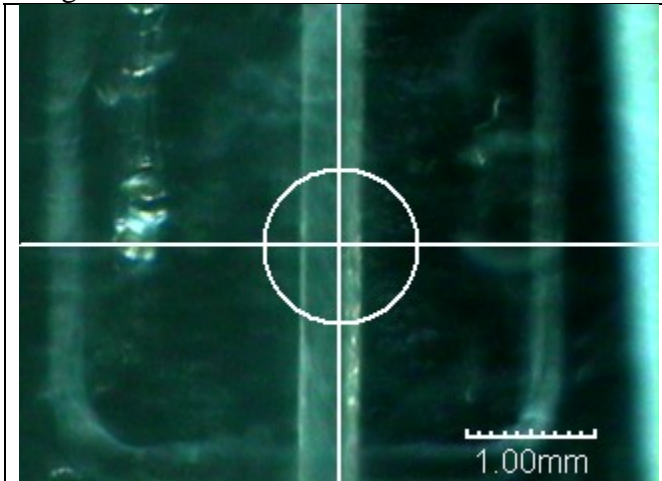
Magnified Picture

Test #: NAC100690
 Date/Time: 6/27/2007 1:04:00 PM
 Part Number: 97F9041S
 Manufacture: GE
 Lot#: JC0049540

Material	Element	MDL	ppm
Metal	Br	1000	N.D.
	Cr	1000	N.D.
	Hg	1000	N.D.
	Cd	100	N.D.
	Pb	1000	N.D.

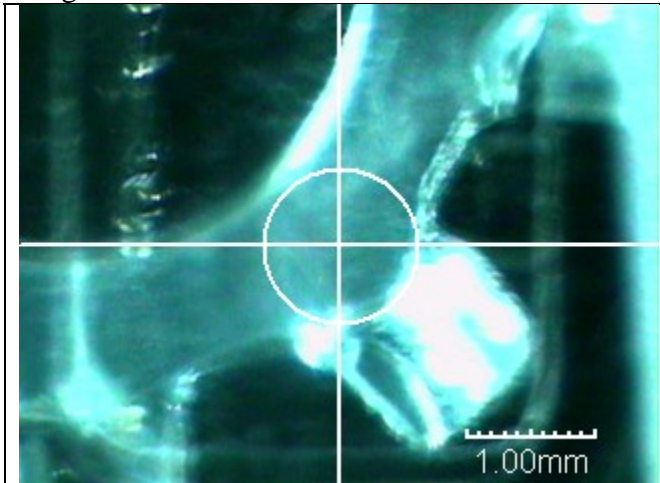
Magnified Picture

Test #: NAC100688
 Date/Time: 6/27/2007 11:32:00 AM
 Part Number: LOCK WASHER
 Manufacture: MISC
 Lot#: UNKNOWN

Material	Element	MDL	ppm
Metal	Br	1000	N.D.
	Cr	1000	N.D.
	Hg	1000	N.D.
	Cd	100	N.D.
	Pb	1000	N.D.

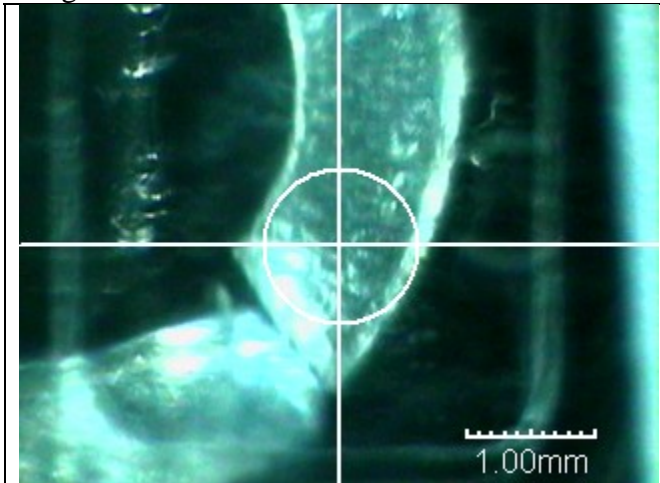
Magnified Picture

Test #: NAC100687
 Date/Time: 6/27/2007 11:18:00 AM
 Part Number: SMALL WASHER
 Manufacture: MISC
 Lot#: UNKNOWN

Material	Element	MDL	ppm
Metal	Br	1000	N.D.
	Cr	1000	N.D.
	Hg	1000	N.D.
	Cd	100	N.D.
	Pb	1000	N.D.

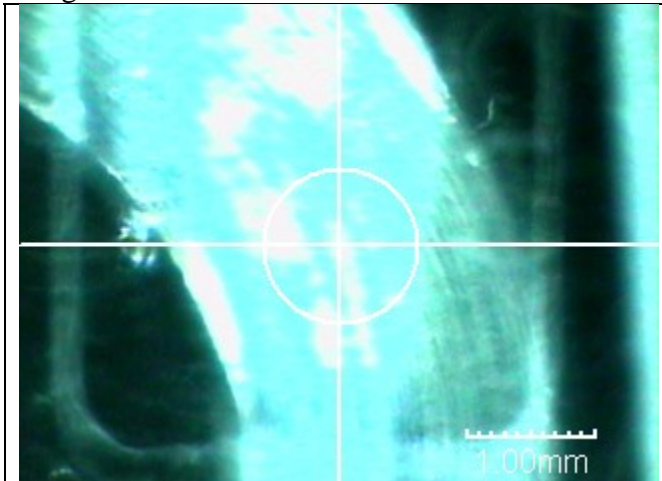
Magnified Picture

Test #: NAC100684
 Date/Time: 6/27/2007 9:27:00 AM
 Part Number: WASHER
 Manufacture: MISC
 Lot#: UNKNOWN

Material	Element	MDL	ppm
Metal	Br	1000	N.D.
	Cr	1000	N.D.
	Hg	1000	N.D.
	Cd	100	N.D.
	Pb	1000	N.D.

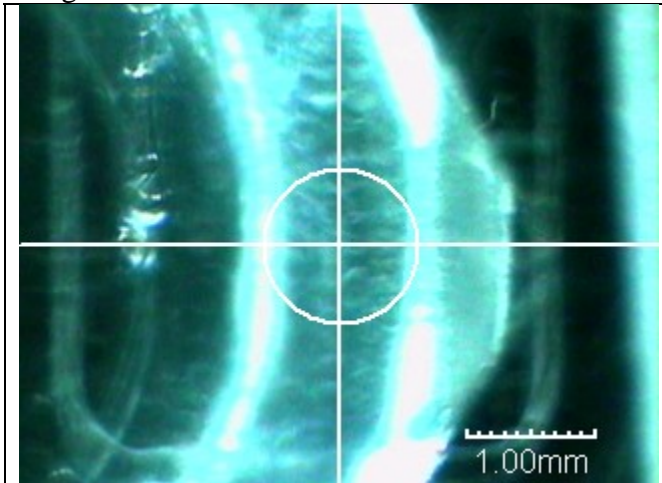
Magnified Picture

Test #: NAC100683
 Date/Time: 6/27/2007 9:08:00 AM
 Part Number: NUT
 Manufacture: MISC
 Lot#: UNKNOWN

Material	Element	MDL	ppm
Metal	Br	1000	N.D.
	Cr	1000	N.D.
	Hg	1000	N.D.
	Cd	100	N.D.
	Pb	1000	N.D.

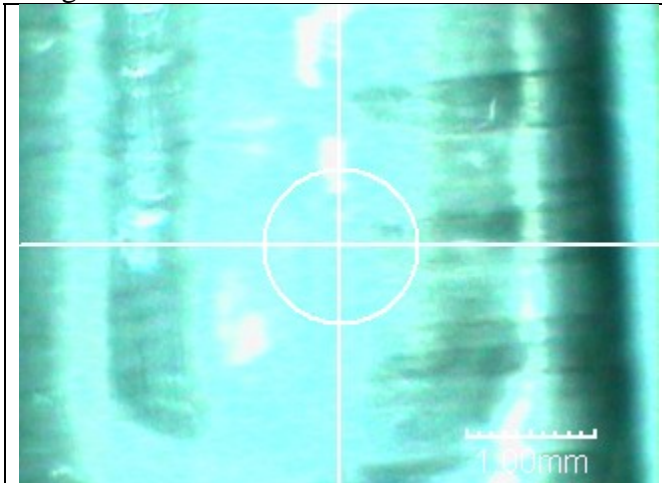
Magnified Picture

Test #: NAC100680
 Date/Time: 6/26/2007 5:03:00 PM
 Part Number: CRIMP TERMINAL 12-10
 Manufacture: ETC
 Lot#: UNKNOWN

Material	Element	MDL	ppm
Metal	Br	1000	N.D.
	Cr	1000	N.D.
	Hg	1000	N.D.
	Cd	100	N.D.
	Pb	1000	N.D.

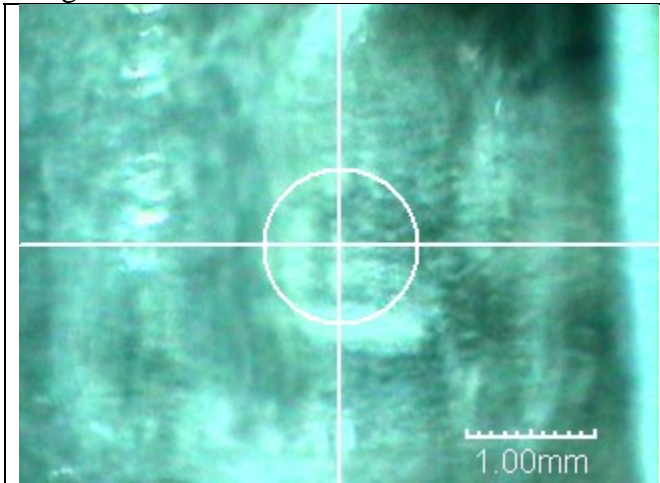
Magnified Picture

Test #: NAC100679
 Date/Time: 6/26/2007 4:47:00 PM
 Part Number: CRIMP TERMINAL 12-10
 Manufacture: MISC
 Lot#: UNKNOWN

Material	Element	MDL	ppm
Metal	Br	1000	N.D.
	Cr	1000	N.D.
	Hg	1000	N.D.
	Cd	100	N.D.
	Pb	1000	N.D.

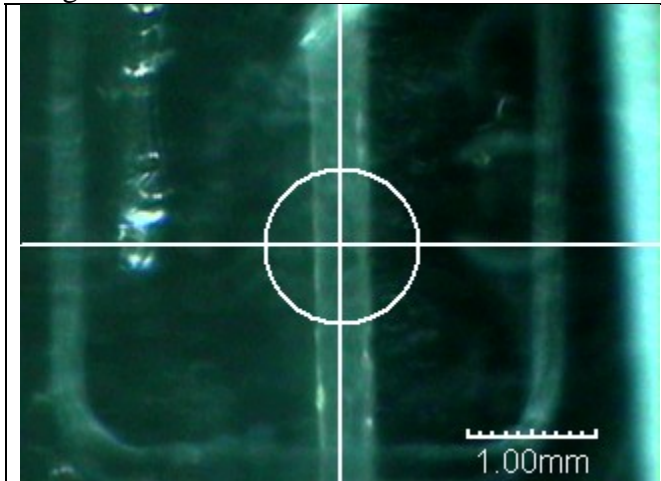
Magnified Picture

Test #: NAC100677
 Date/Time: 6/26/2007 3:21:00 PM
 Part Number: 6-370V
 Manufacture: MISC
 Lot#: UNKNOWN

Material	Element	MDL	ppm
Metal	Br	1000	N.D.
	Cr	1000	N.D.
	Hg	1000	N.D.
	Cd	100	N.D.
	Pb	1000	N.D.
